## ***ENGINEERING REPORT***

### **FAA CONTRACT NO. DTFA03-02-C-00044 PHASE 1, CLIN 0001f (TASK 6) - PRE-TEARDOWN INSPECTION REPORT**

This report supports Task 6 of FAA Contract No. DTFA03-02-C-00044. Various NDT and visual inspections were accomplished on panels which were removed from aircraft N474DA, a Boeing 727-232. The pre-teardown inspections were conducted after aircraft disassembly and prior to teardown and destructive testing. This report provides details and results of the inspections, including procedures used, locations and documentation of defect indications noted, detailed fastener parameters, condition of the panels after aircraft disassembly, and a comparison of the Field Inspections previously accomplished.

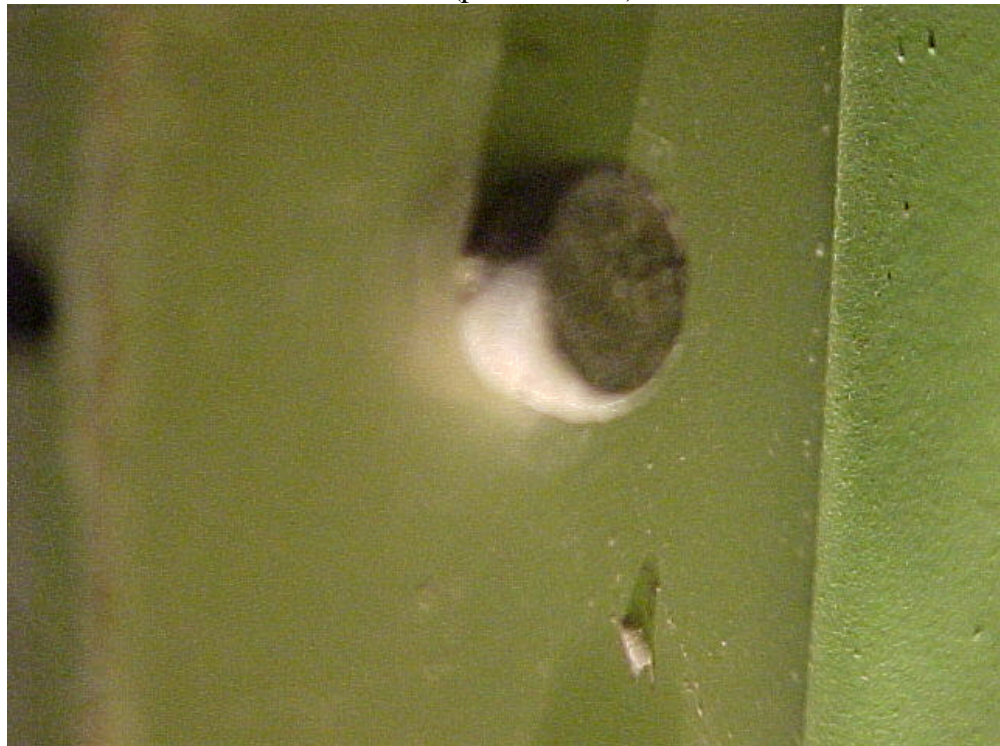
Figure D-26. Photograph showing internal detailed visual inspection indication at BS 540, stringer 4R, rivet 6 (panel FT1/F3).

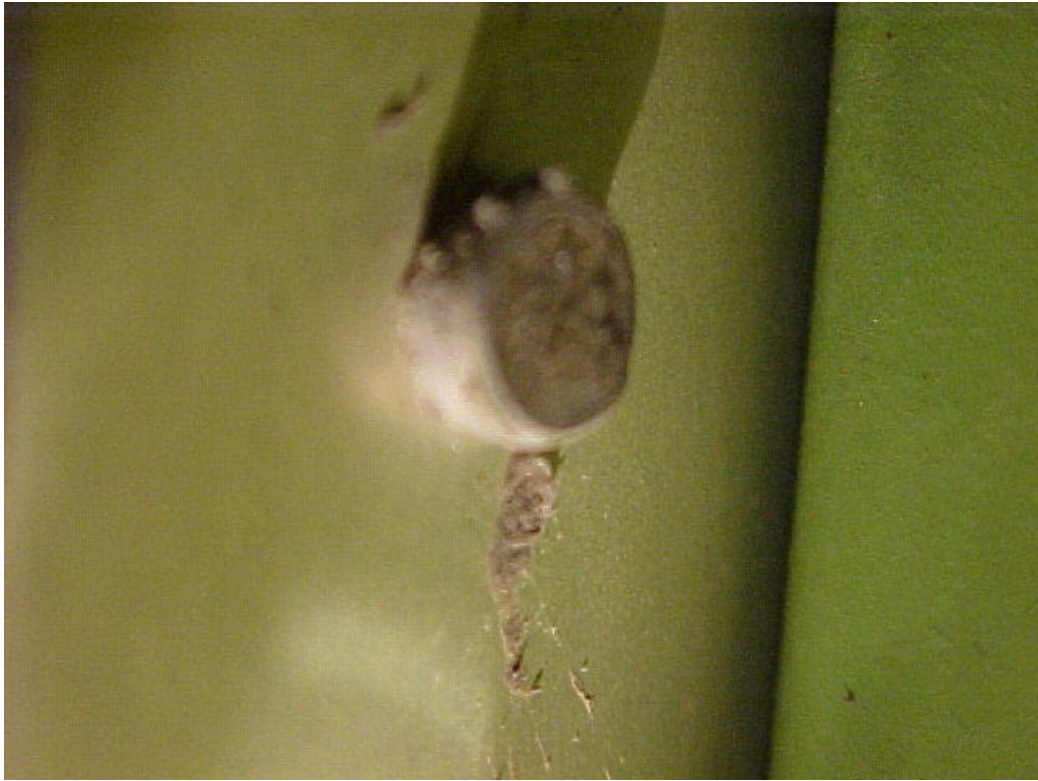
Figure D-27. Photograph showing internal detailed visual inspection indication at BS 540, stringer 4R, rivet 7 (panel FT1/F3).

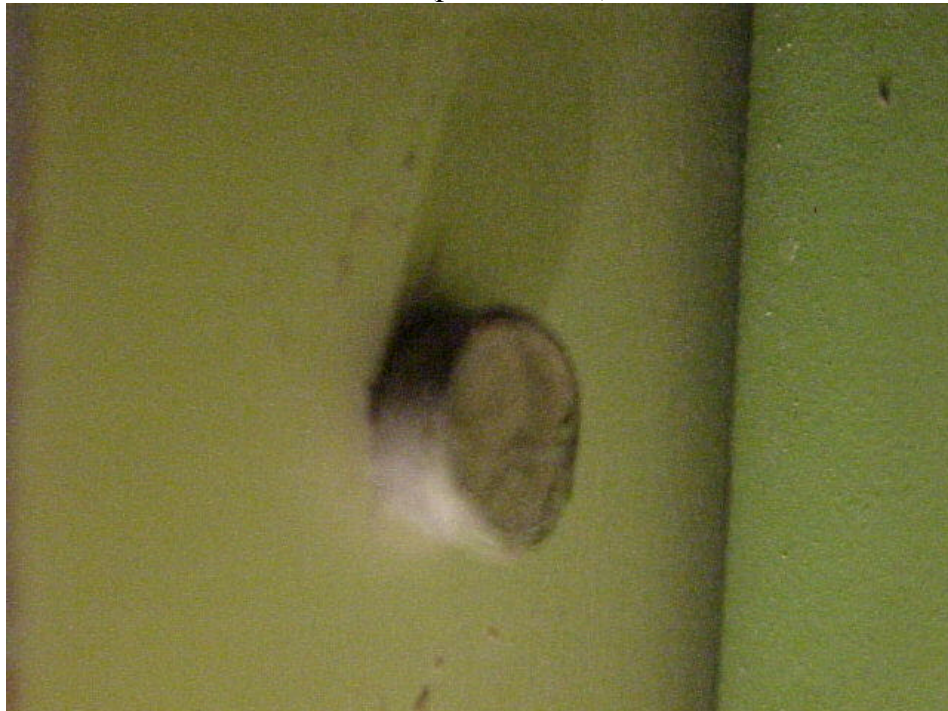
Figure D-28. Photograph showing internal detailed visual inspection indication at BS 540, stringer 4R, rivet 8 (panel FT1/F3).

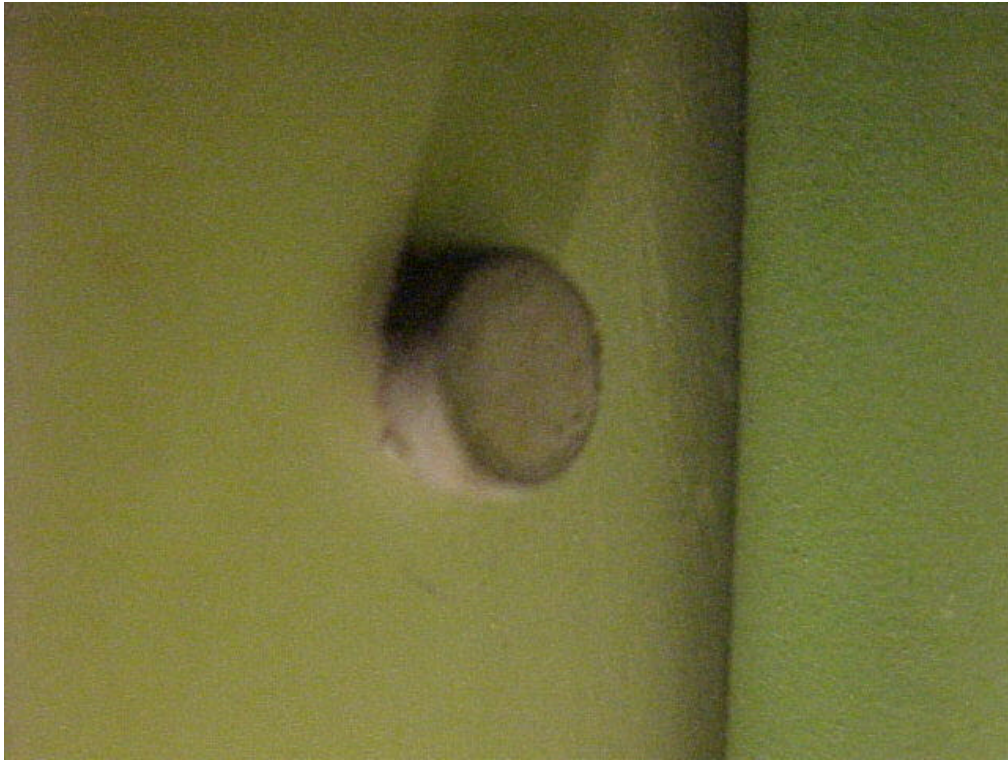
Figure D-29. Photograph showing internal detailed visual inspection indication at BS 540, stringer 4R, rivet 9 (panel FT1/F3).

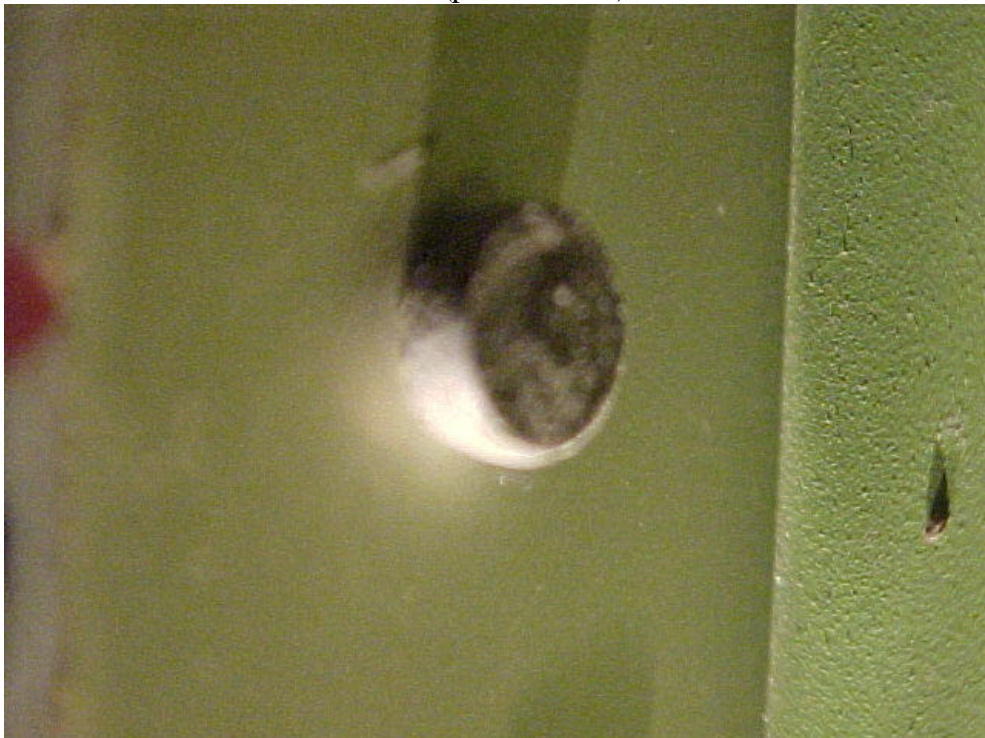
Figure D-30. Photograph showing internal detailed visual inspection indication at BS 540, stringer 4R, rivet 10 (panel FT1/F3).

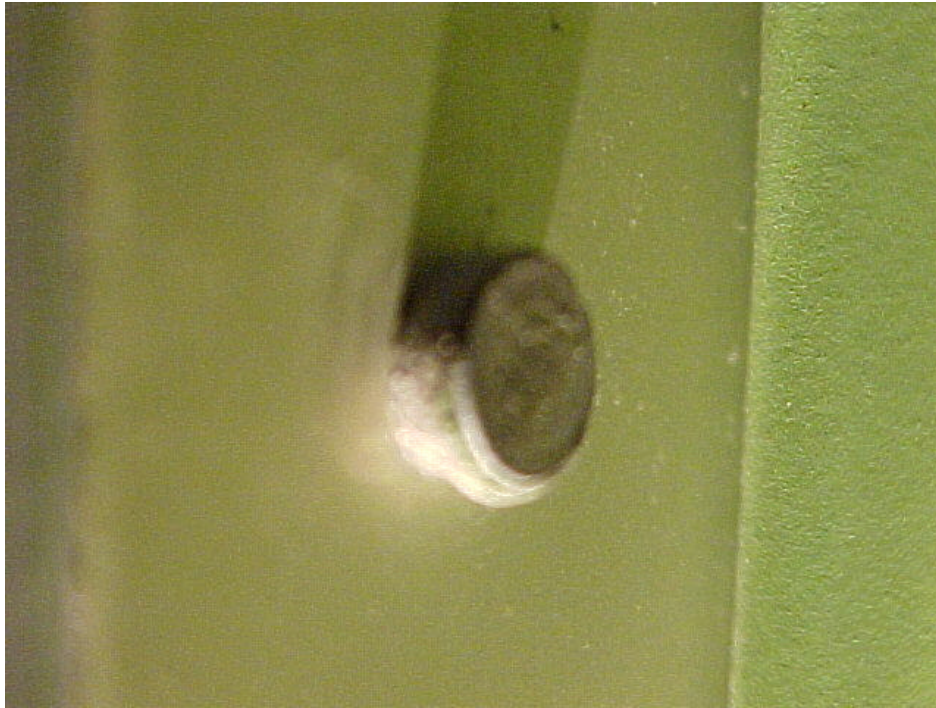
Figure D-31. Photograph showing internal detailed visual inspection indication at BS 540, stringer 4R, rivet 13 (panel FT1/F3).

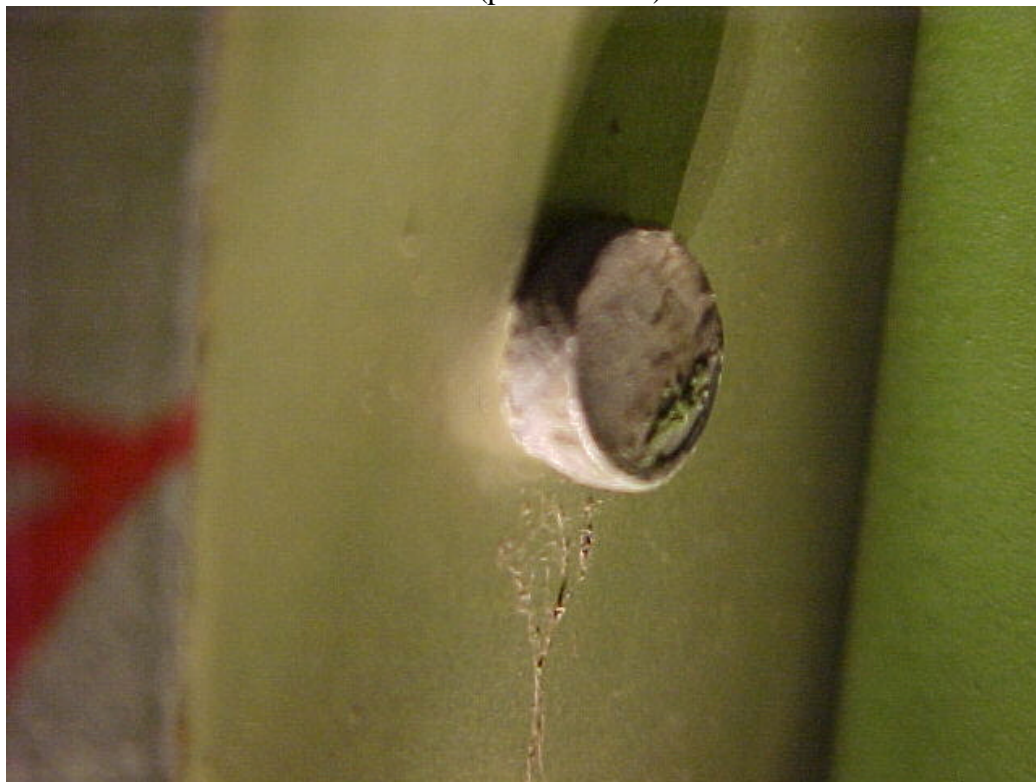
Figure D-32. Photograph showing internal detailed visual inspection indication at BS 540, stringer 4R, rivet 14 (panel FT1/F3).

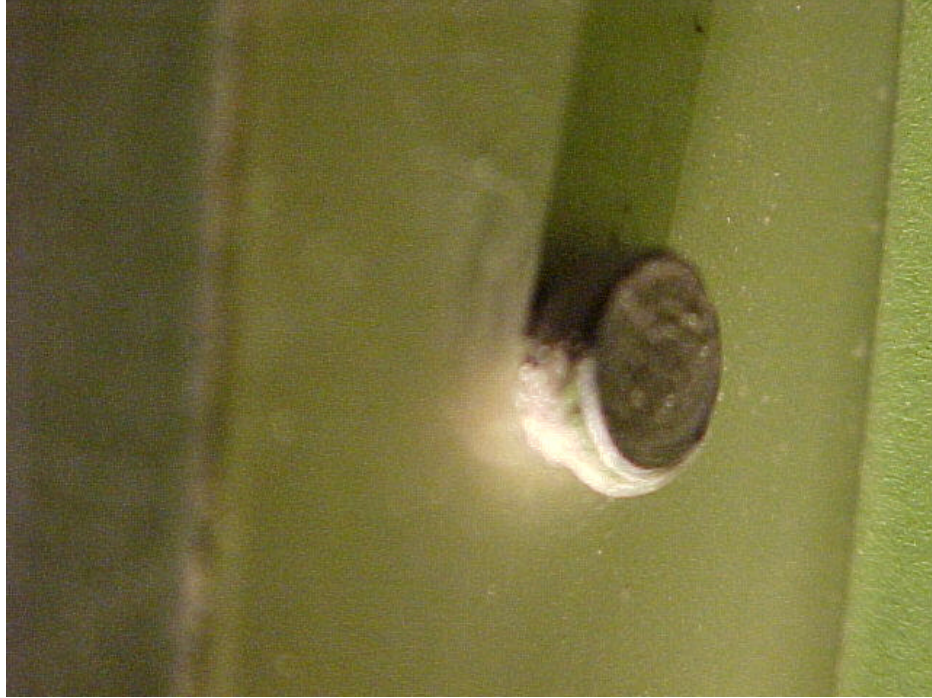
Figure D-33. Photograph showing internal detailed visual inspection indication at BS 540, stringer 4R, rivet 15 (panel FT1/F3).

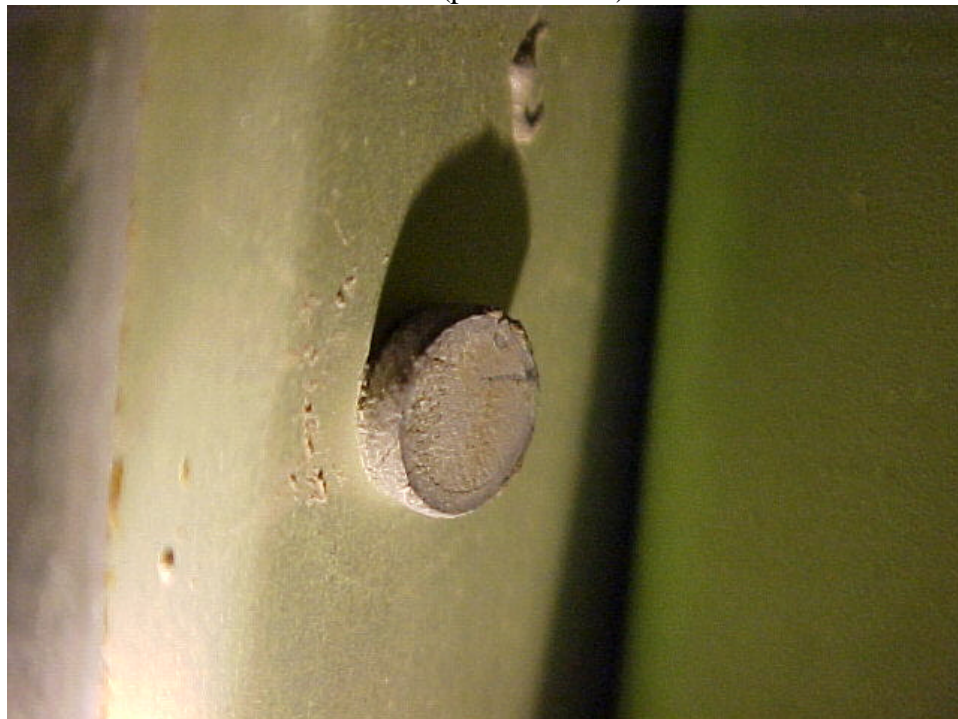
Figure D-34. Photograph showing internal detailed visual inspection indication at BS 560, stringer 4R, rivet 11 (panel FT1/F3).

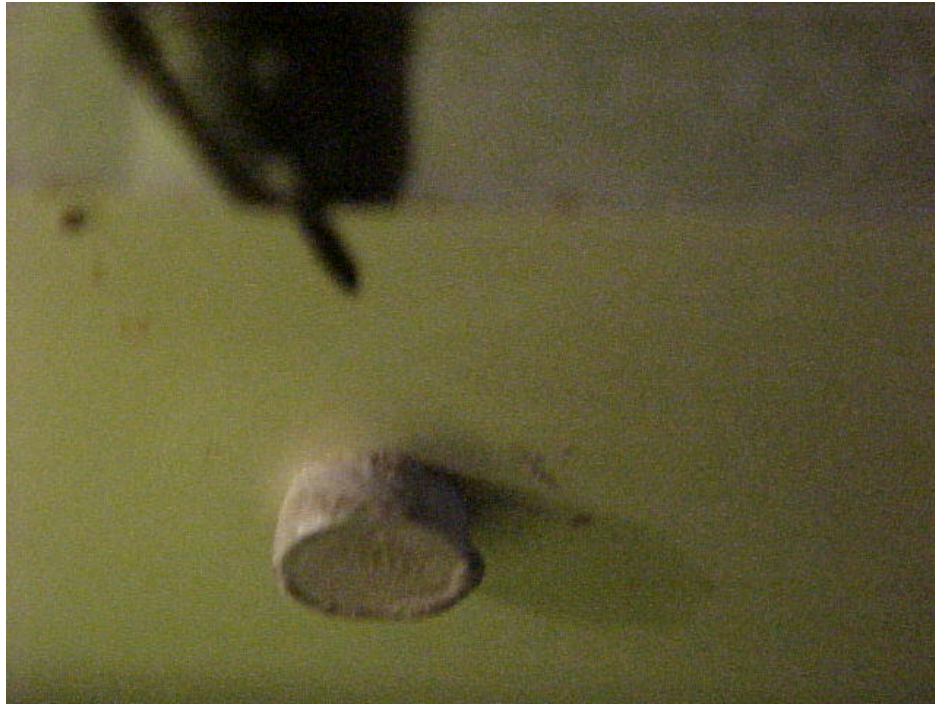
Figure D-35. Photograph showing internal detailed visual inspection indication at BS 600, stringer 4R, rivet 9 (panel FT2/F4).

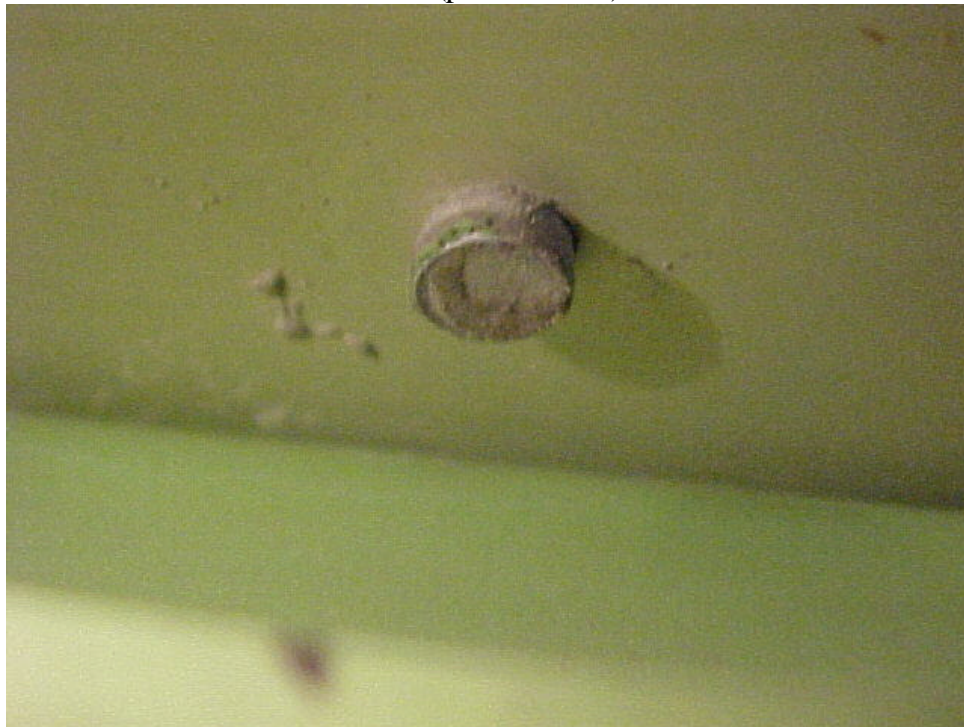
Figure D-36. Photograph showing internal detailed visual inspection indication at BS 600, stringer 4R, rivet 10 (panel FT2/F4).

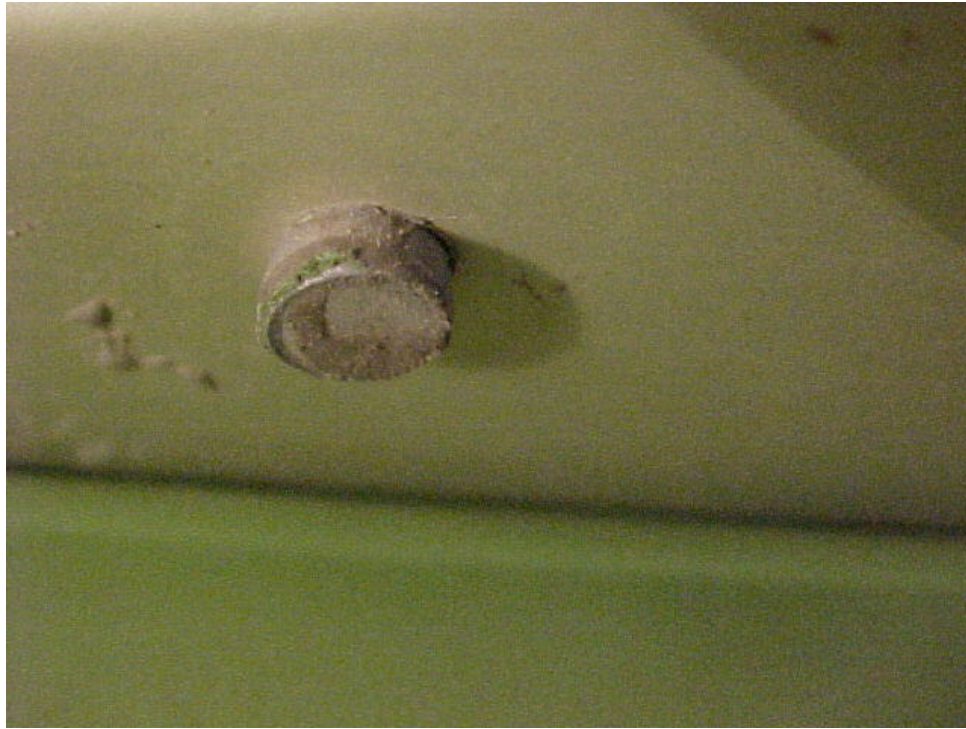
Figure D-37. Photograph showing internal detailed visual inspection indication at BS 600, stringer 4R, rivet 11 (panel FT2/F4).

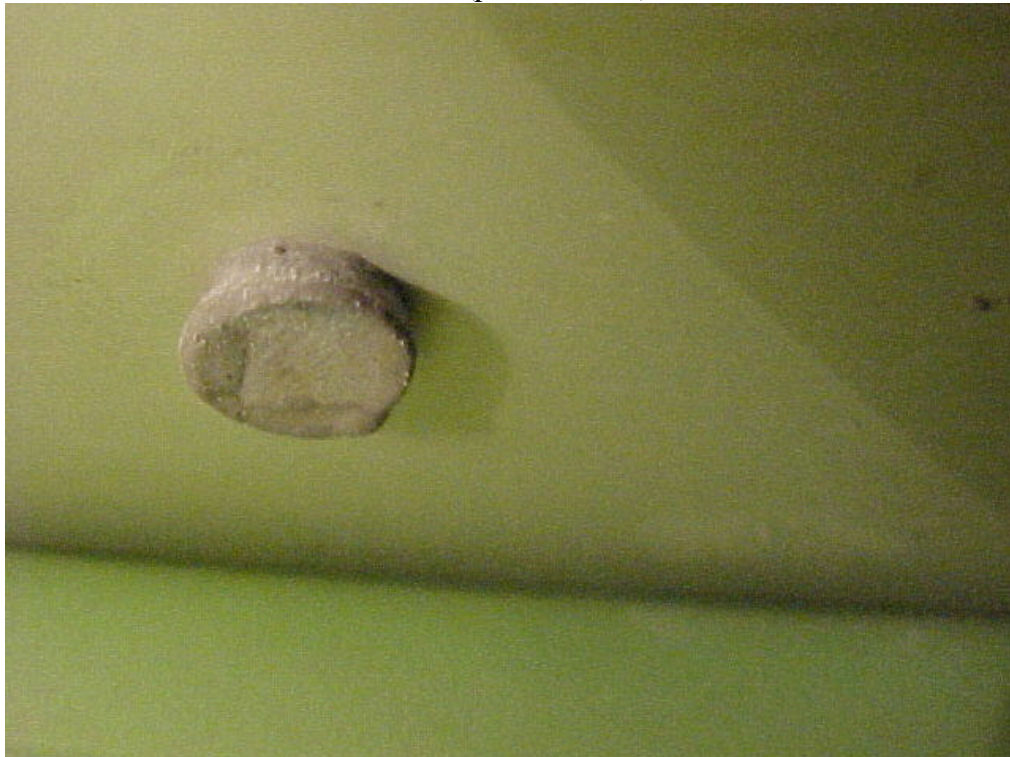
Figure D-38. Photograph showing internal detailed visual inspection indication at BS 620, stringer 4R, rivet 4 (panel FT2/F4).

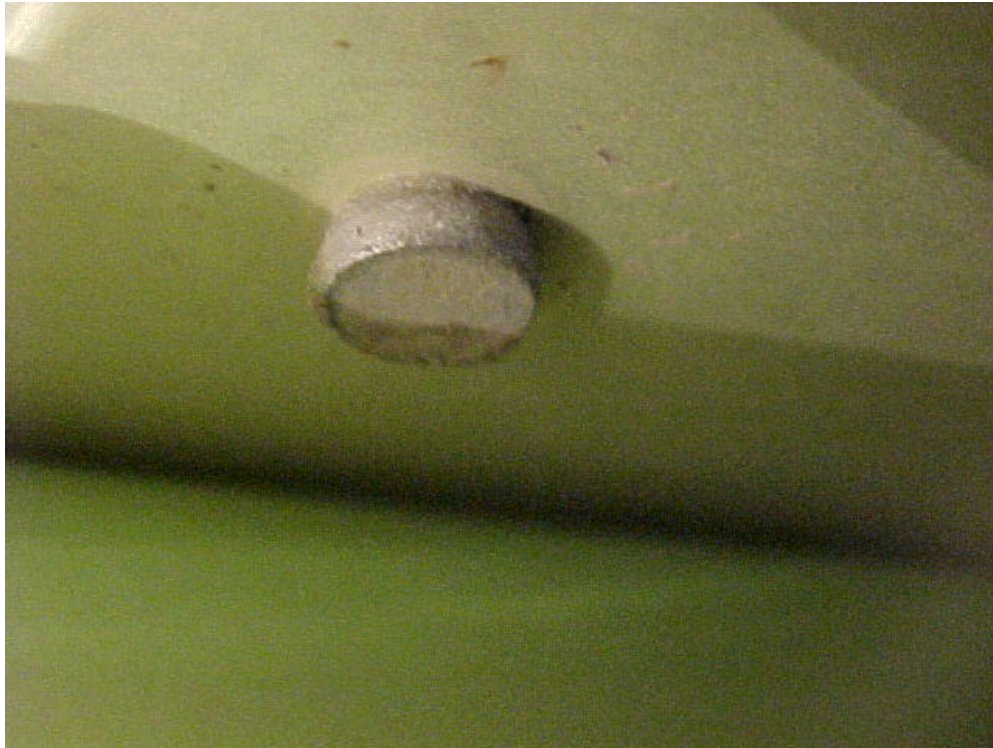
Figure D-39. Photograph showing internal detailed visual inspection indication at BS 620, stringer 4R, rivet 5 (panel FT2/F4).

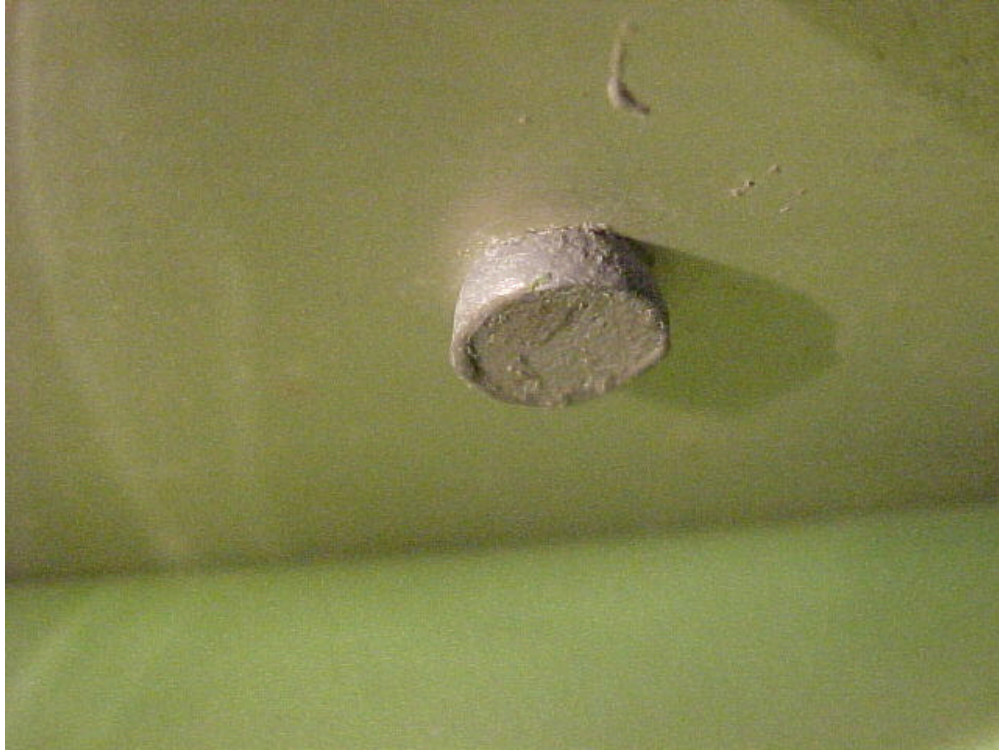
Figure D-41. Photograph showing internal detailed visual inspection indication at BS 620, stringer 4R, rivet 7 (panel FT2/F4).

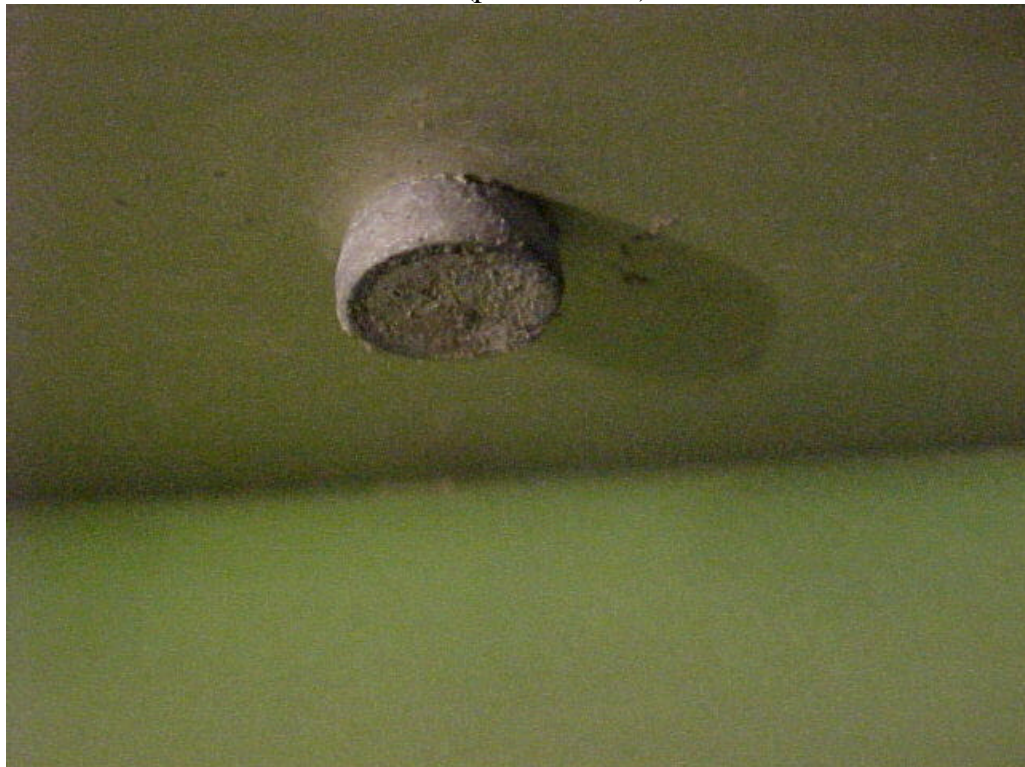
Figure D-42. Photograph showing internal detailed visual inspection indication at BS 620, stringer 4R, rivet 9 (panel FT2/F4).

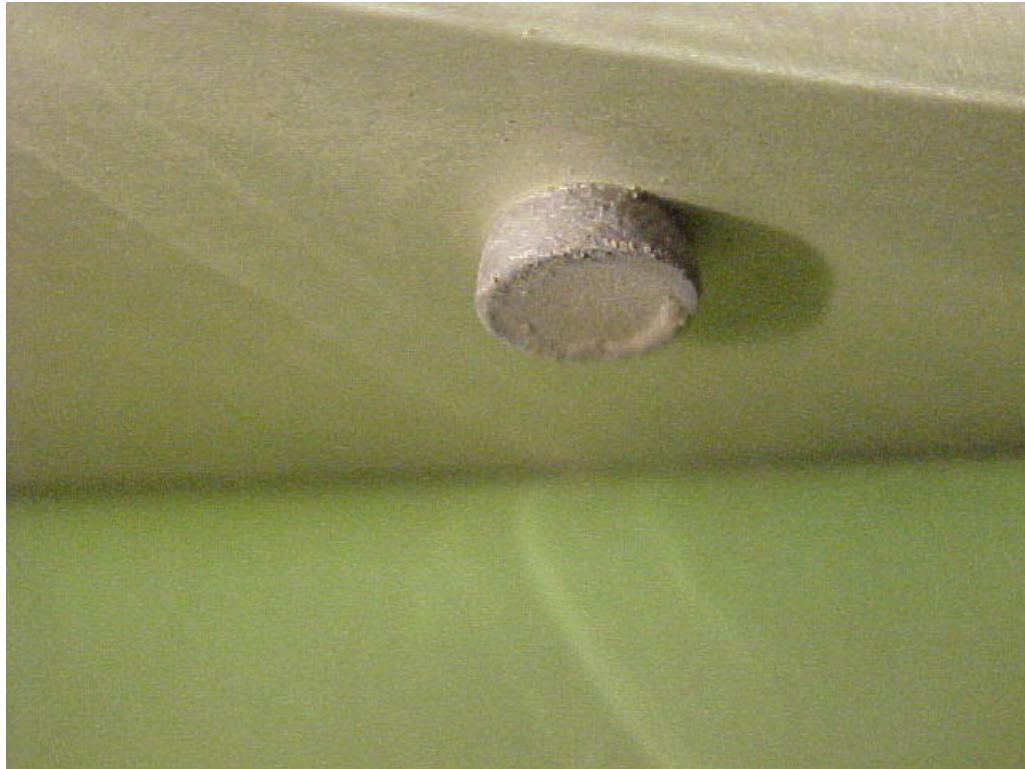
Figure D-43. Photograph showing internal detailed visual inspection indication at BS 720, stringer 4R, rivet 9 (panel FT2/F4).

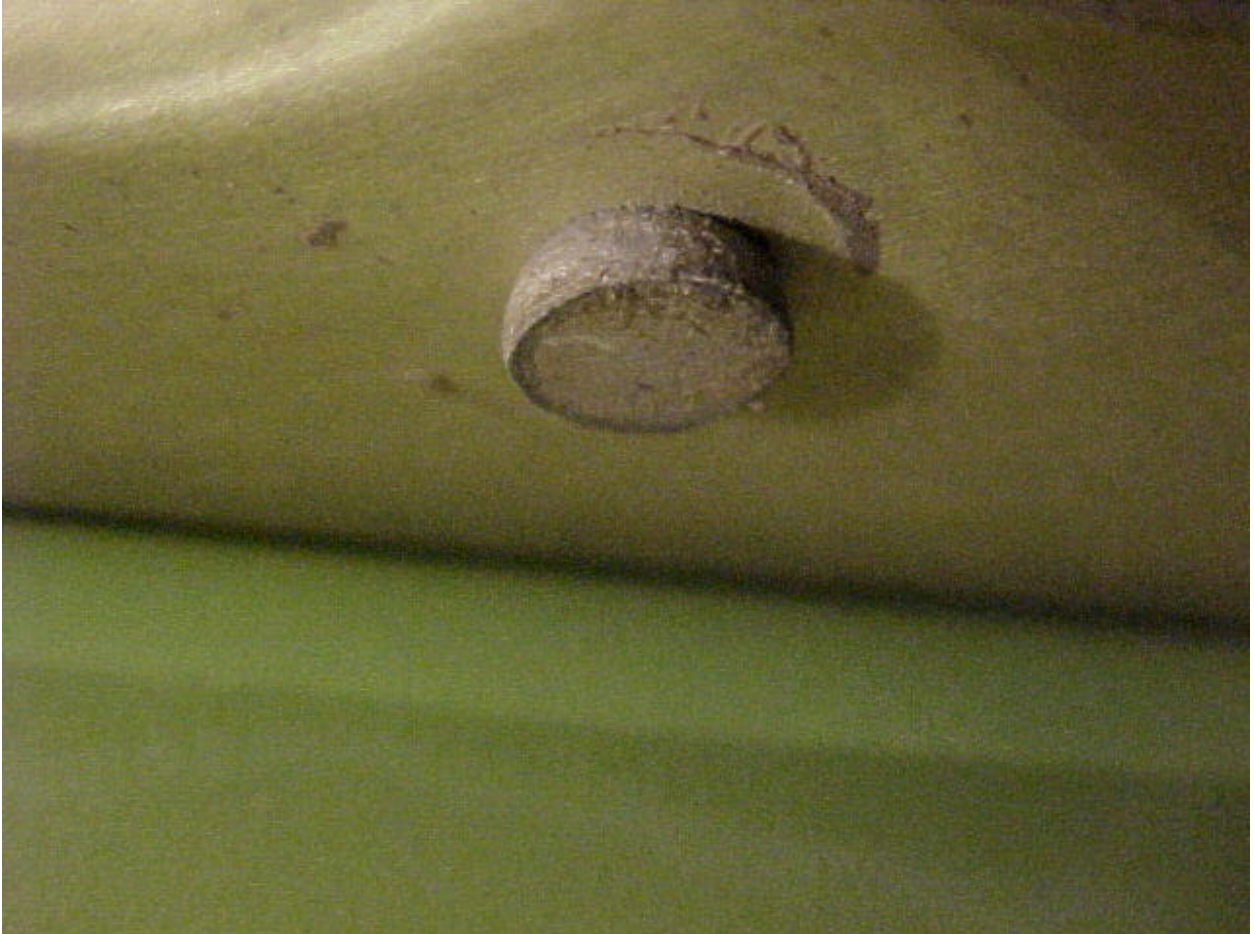
Figure D-47. Photograph showing internal detailed visual inspection indication at BS 720D, stringer 4R, rivet 10 (panel FT3/F5).

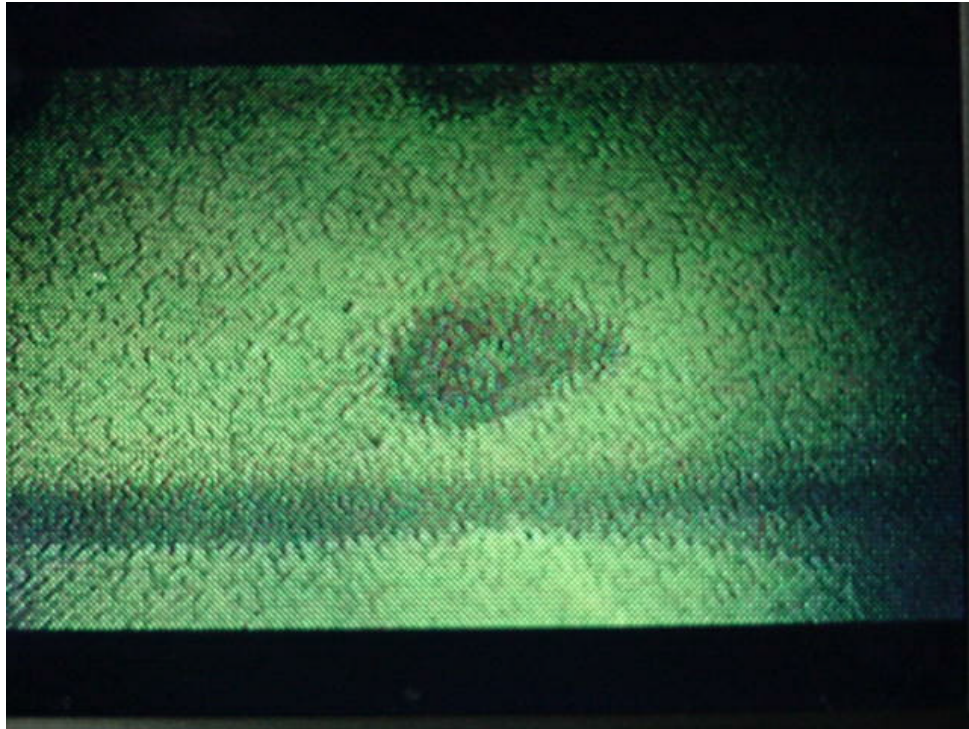
Figure F-1. Screen representation of MOI indication at rivet #11 between BS 520 and BS 540 on the lower row of the longitudinal lap joint at stringer 4R.

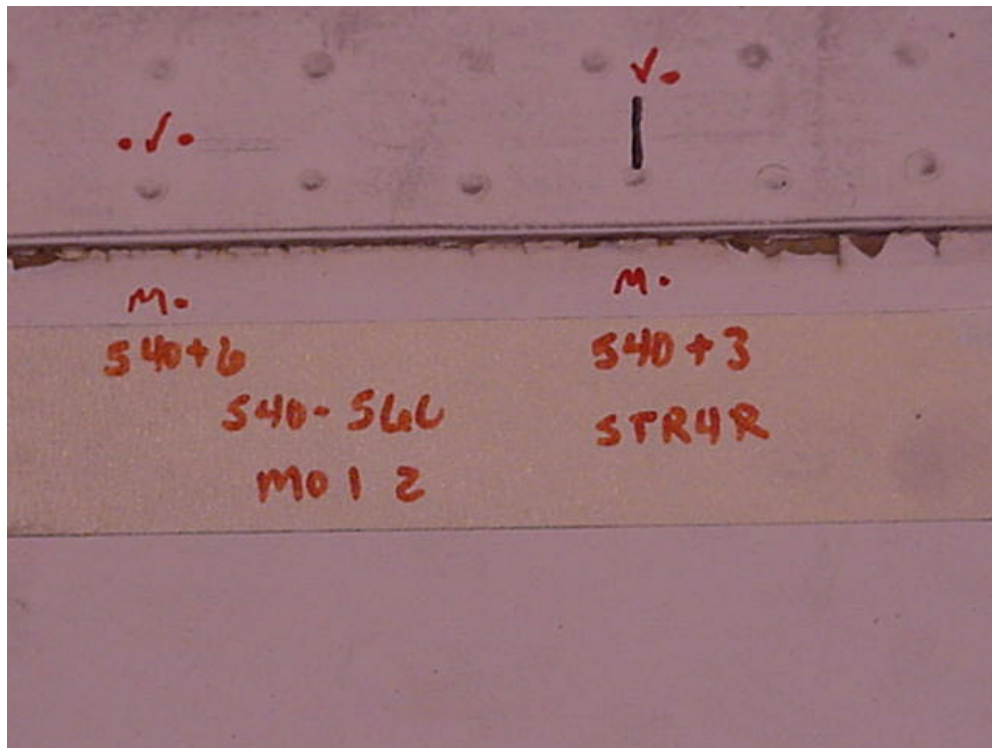
Figure F-4. MOI indications (2 indications at 2 fasteners) found between BS 540 and BS 560 on the lower row of the longitudinal lap joint at stringer 4R.

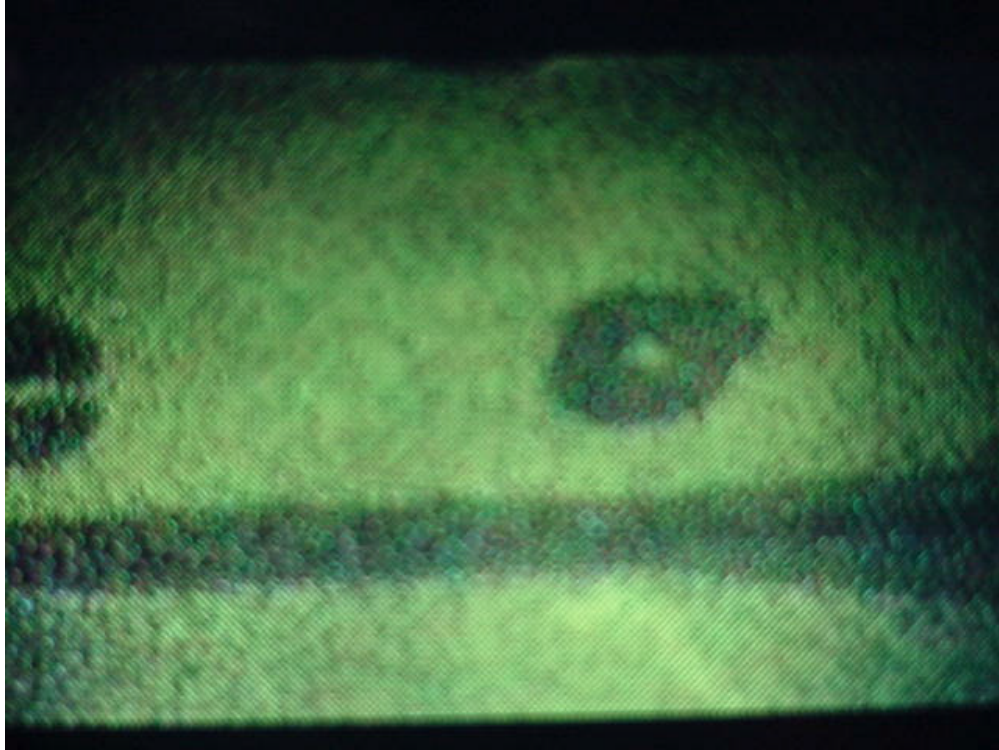
Figure F-5. Screen representation of MOI indication at rivet #3 between BS 540 and BS 560 on the lower row of the longitudinal lap joint at stringer 4R.

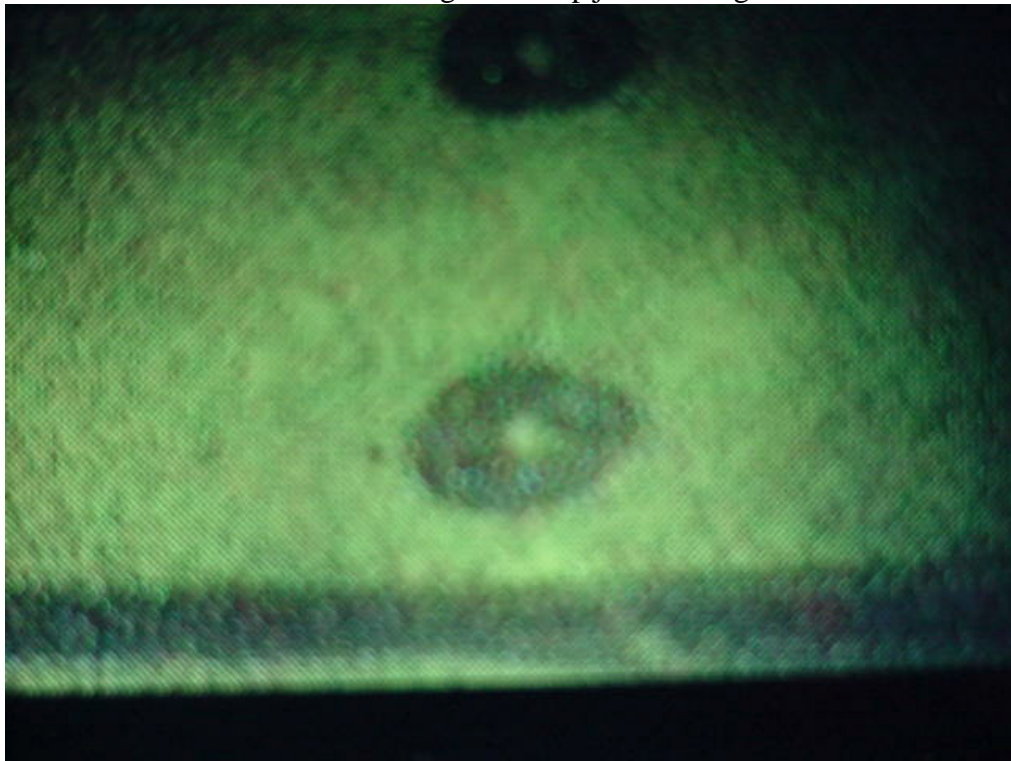
Figure F-6. Screen representation of MOI indication at rivet #6 between BS 540 and BS 560 on the lower row of the longitudinal lap joint at stringer 4R.

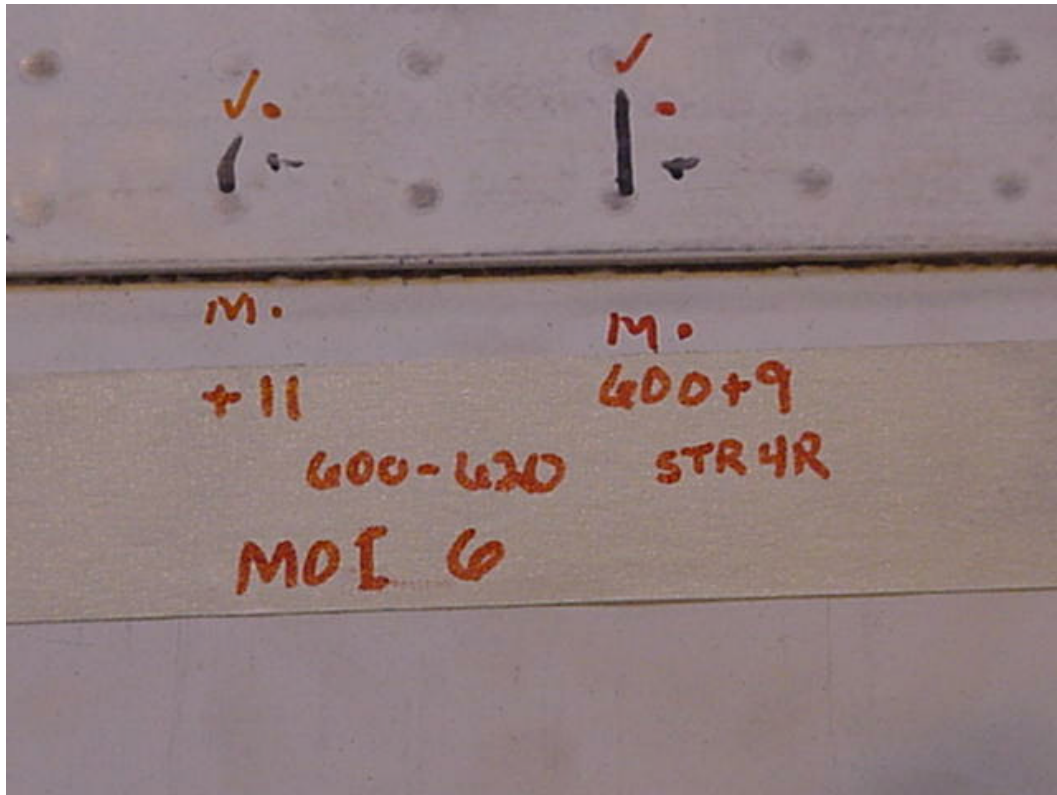
Figure F-7. MOI indications (2 indications at 2 fasteners) found between BS 600 and BS 620 on the lower row of the longitudinal lap joint at stringer 4R.

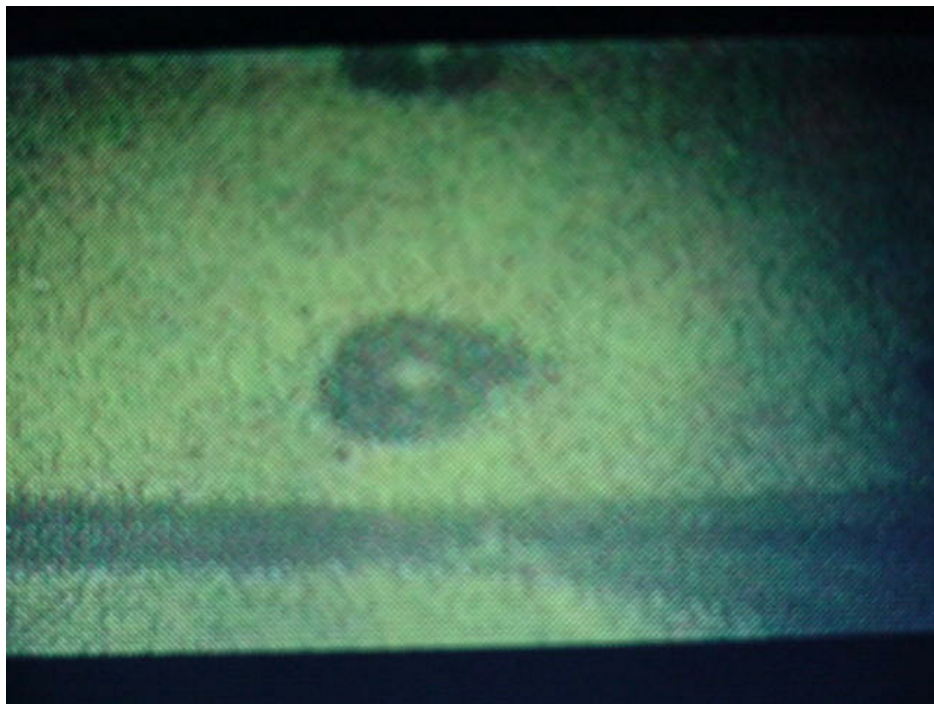
Figure F-8. Screen representation of MOI indication at rivet #9 between BS 600 and BS 620 on the lower row of the longitudinal lap joint at stringer 4R.

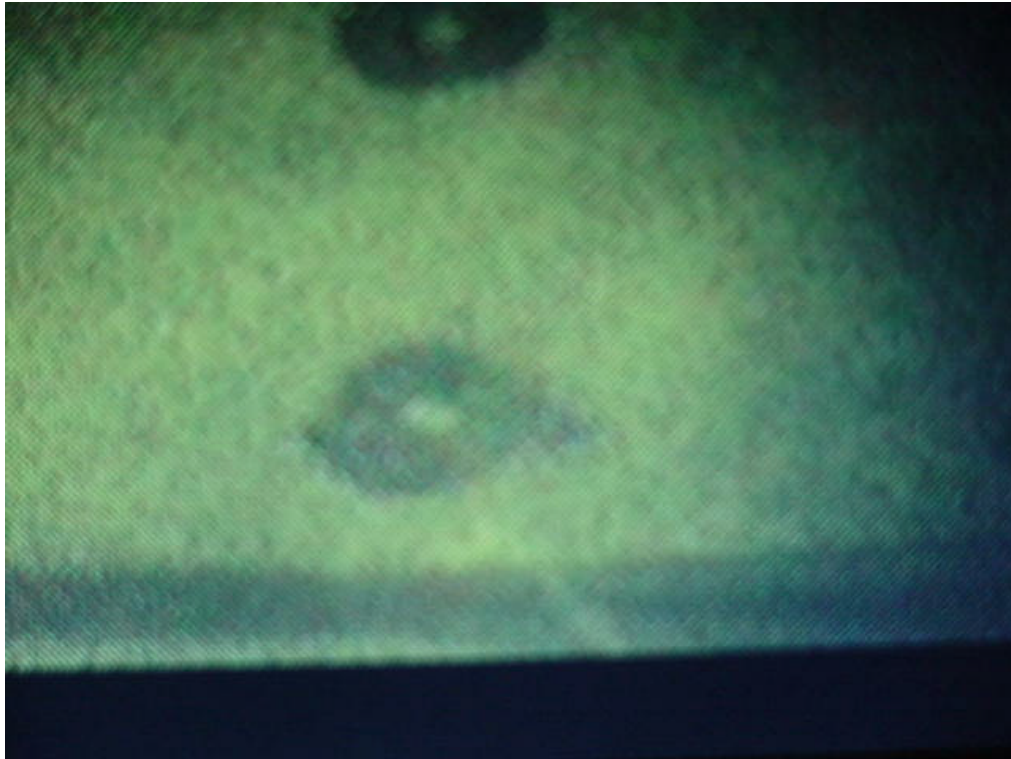
Figure F-9. Screen representation of MOI indication at rivet #11 between BS 600 and BS 620 on the lower row of the longitudinal lap joint at stringer 4R.

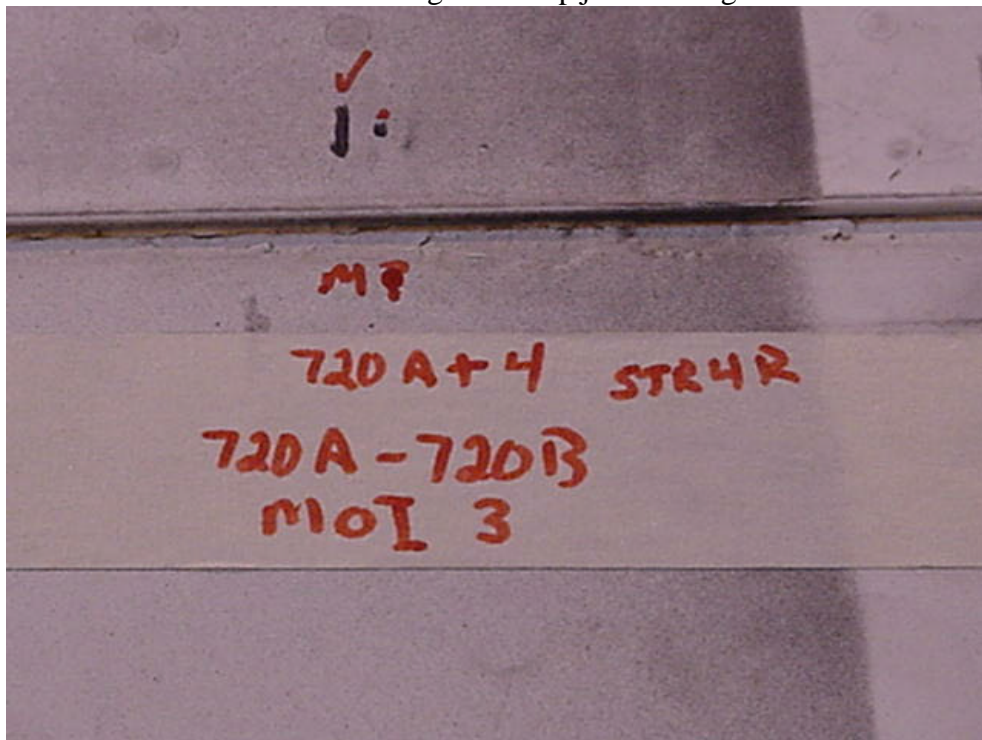
Figure F-10. MOI indications (1 indication at 1 fastener) found between BS 720A and BS 720B on the lower row of the longitudinal lap joint at stringer 4R.

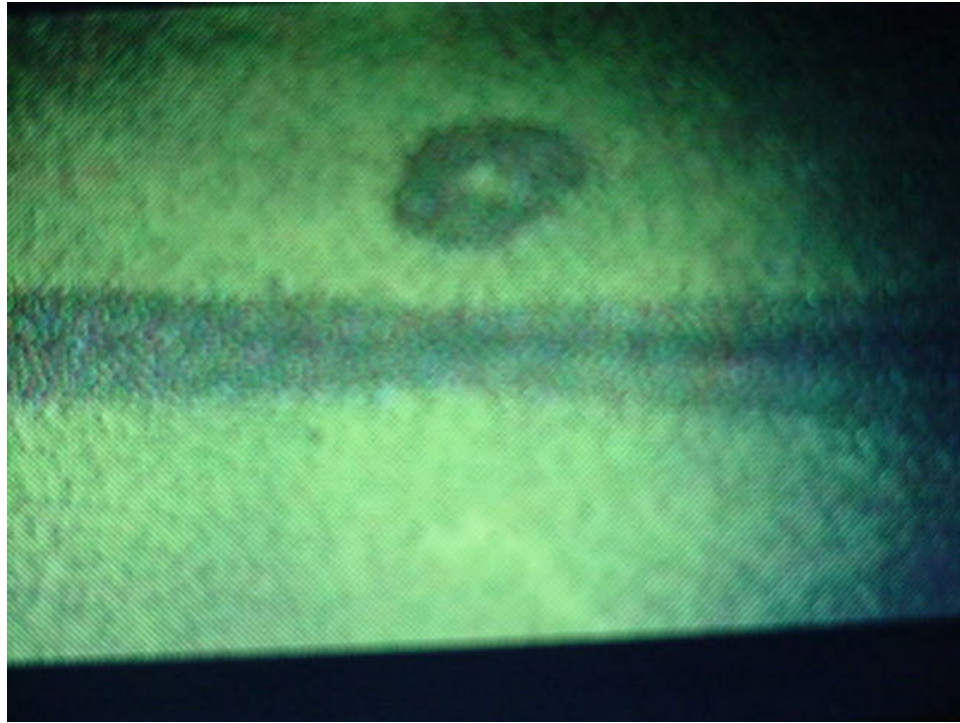
Figure F-11. Screen representation of MOI indication at rivet #4 between BS 720A and BS 720B on the lower row of the longitudinal lap joint at stringer 4R.

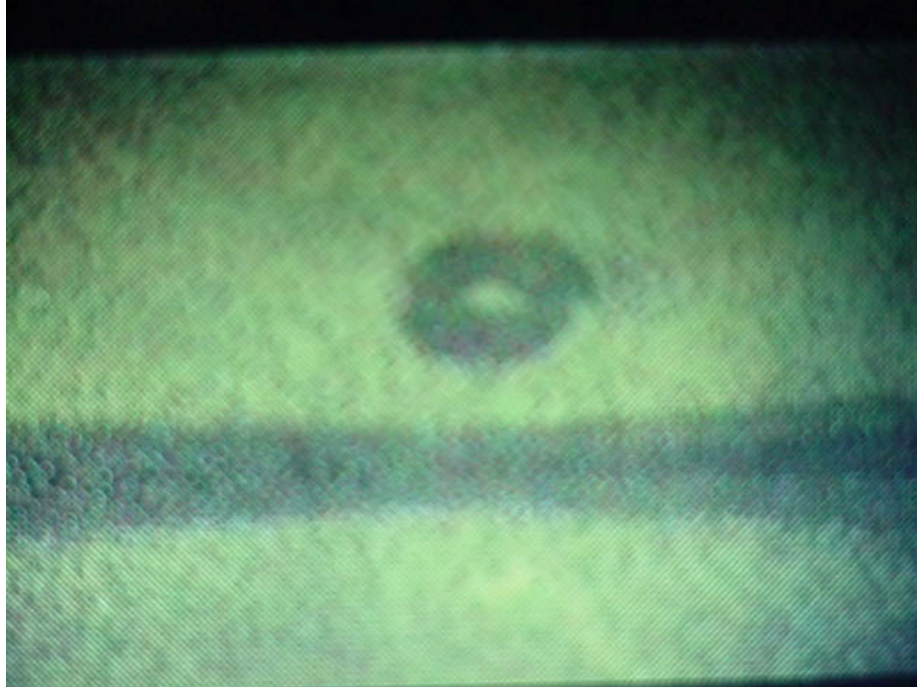
Figure F-13. Screen representation of MOI indication at rivet #5 between BS 720B and BS 720C on the lower row of the longitudinal lap joint at stringer 4R.

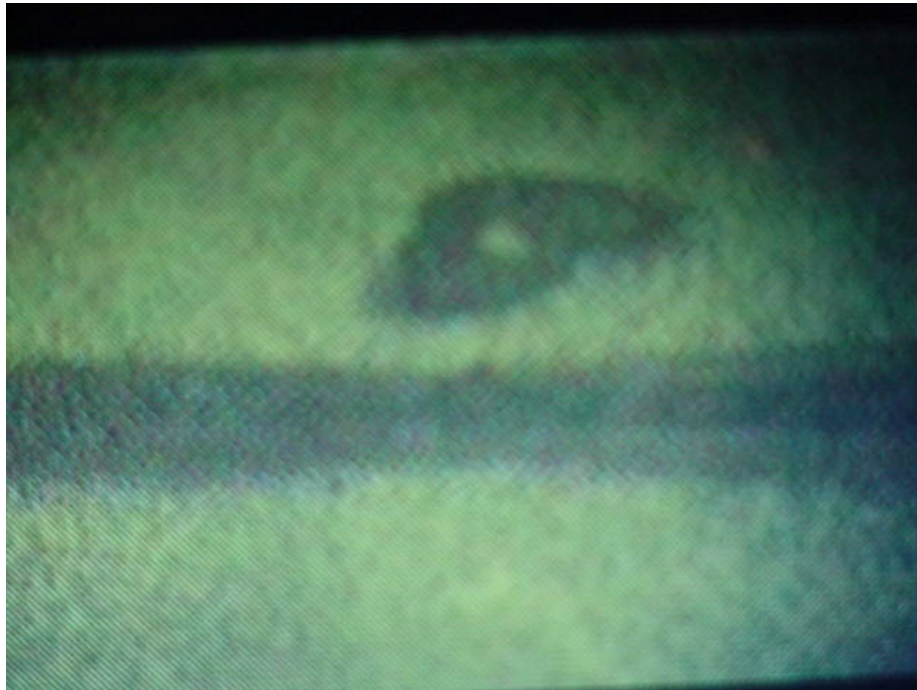
Figure F-14. Screen representation of MOI indication at rivet #7 between BS 720B and BS 720C on the lower row of the longitudinal lap joint at stringer 4R.
